# REPORT OF APOLLO 204 REVIEW BOARD

TO  
THE ADMINISTRATOR  
NATIONAL AERONAUTICS AND SPACE ADMINISTRATION

### **APOLLO SPACECRAFT**

Spacecraft 012 was undergoing a "Plugs Out Integrated Test" at the time of the accident on January 27, 1967. Operational Checkout Procedure, designated OCP FO-K-0021-1 applied to this test. Within this report this procedure is often referred to as OCP-0021.

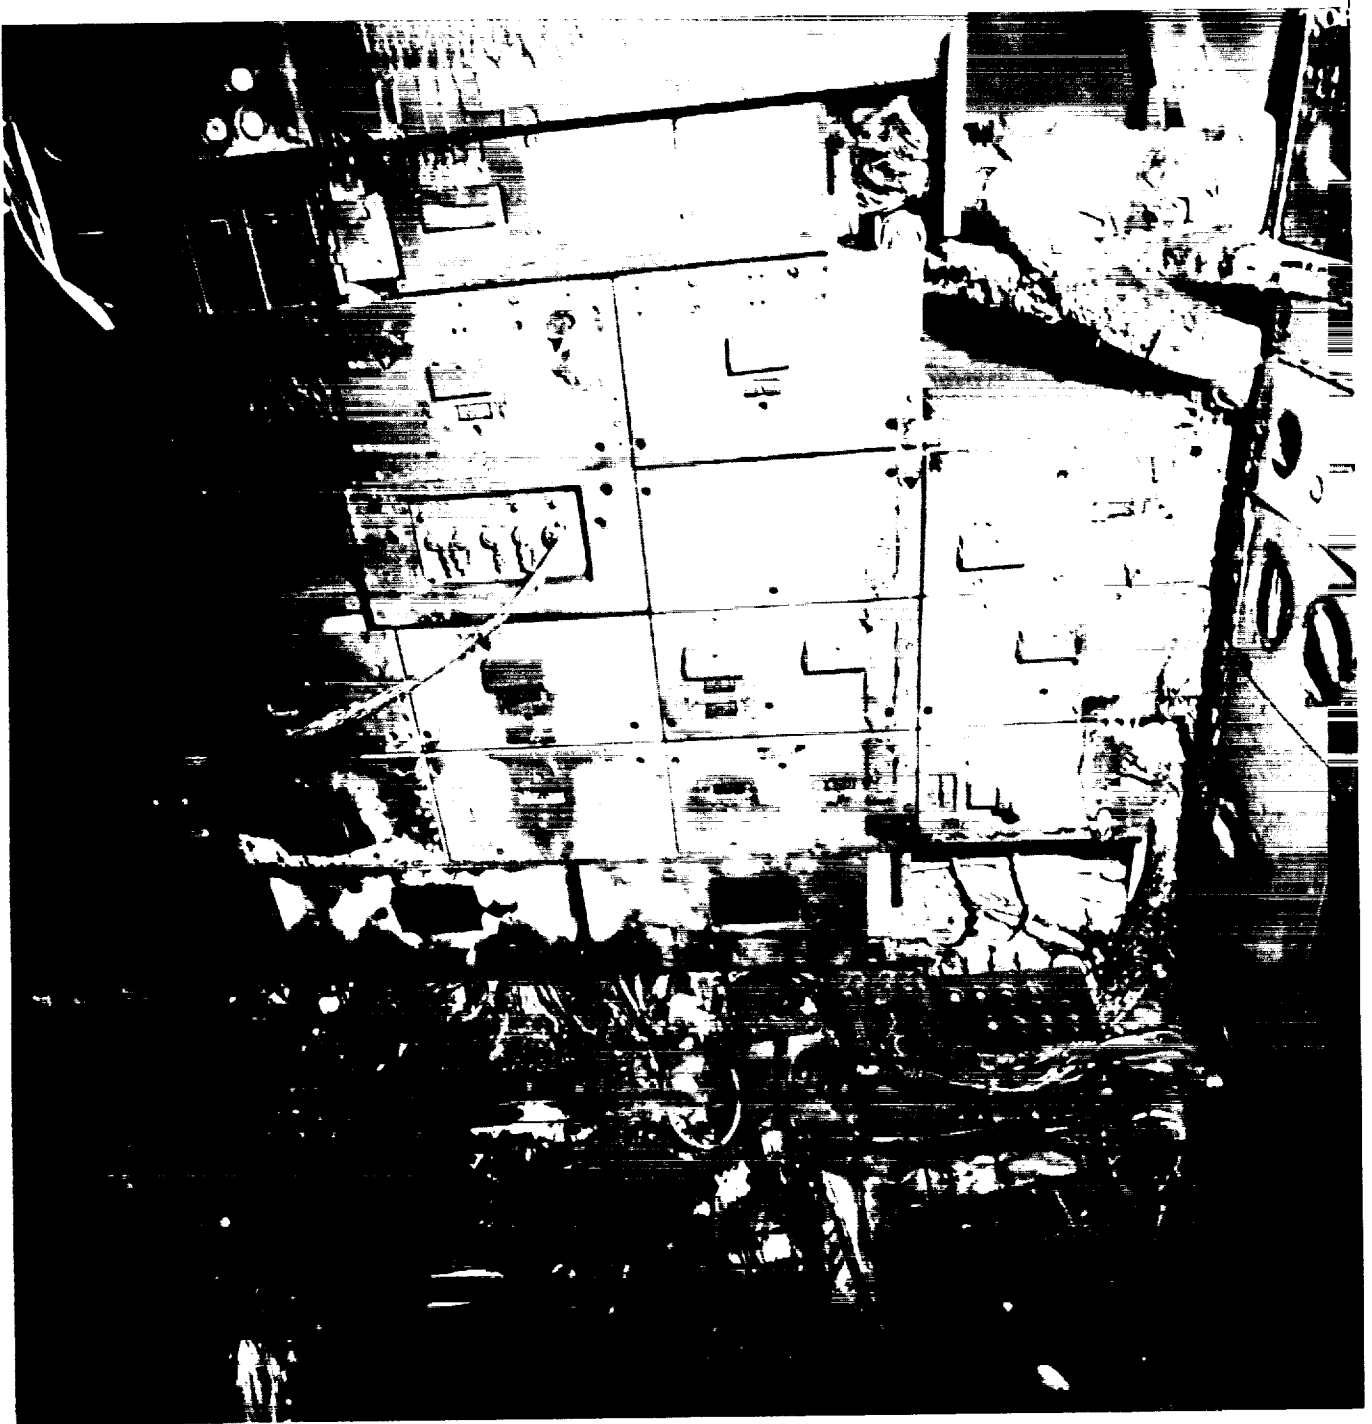
ENCLOSURE V-4

RIGHT HAND SECTION OF LOWER EQUIPMENT BAY

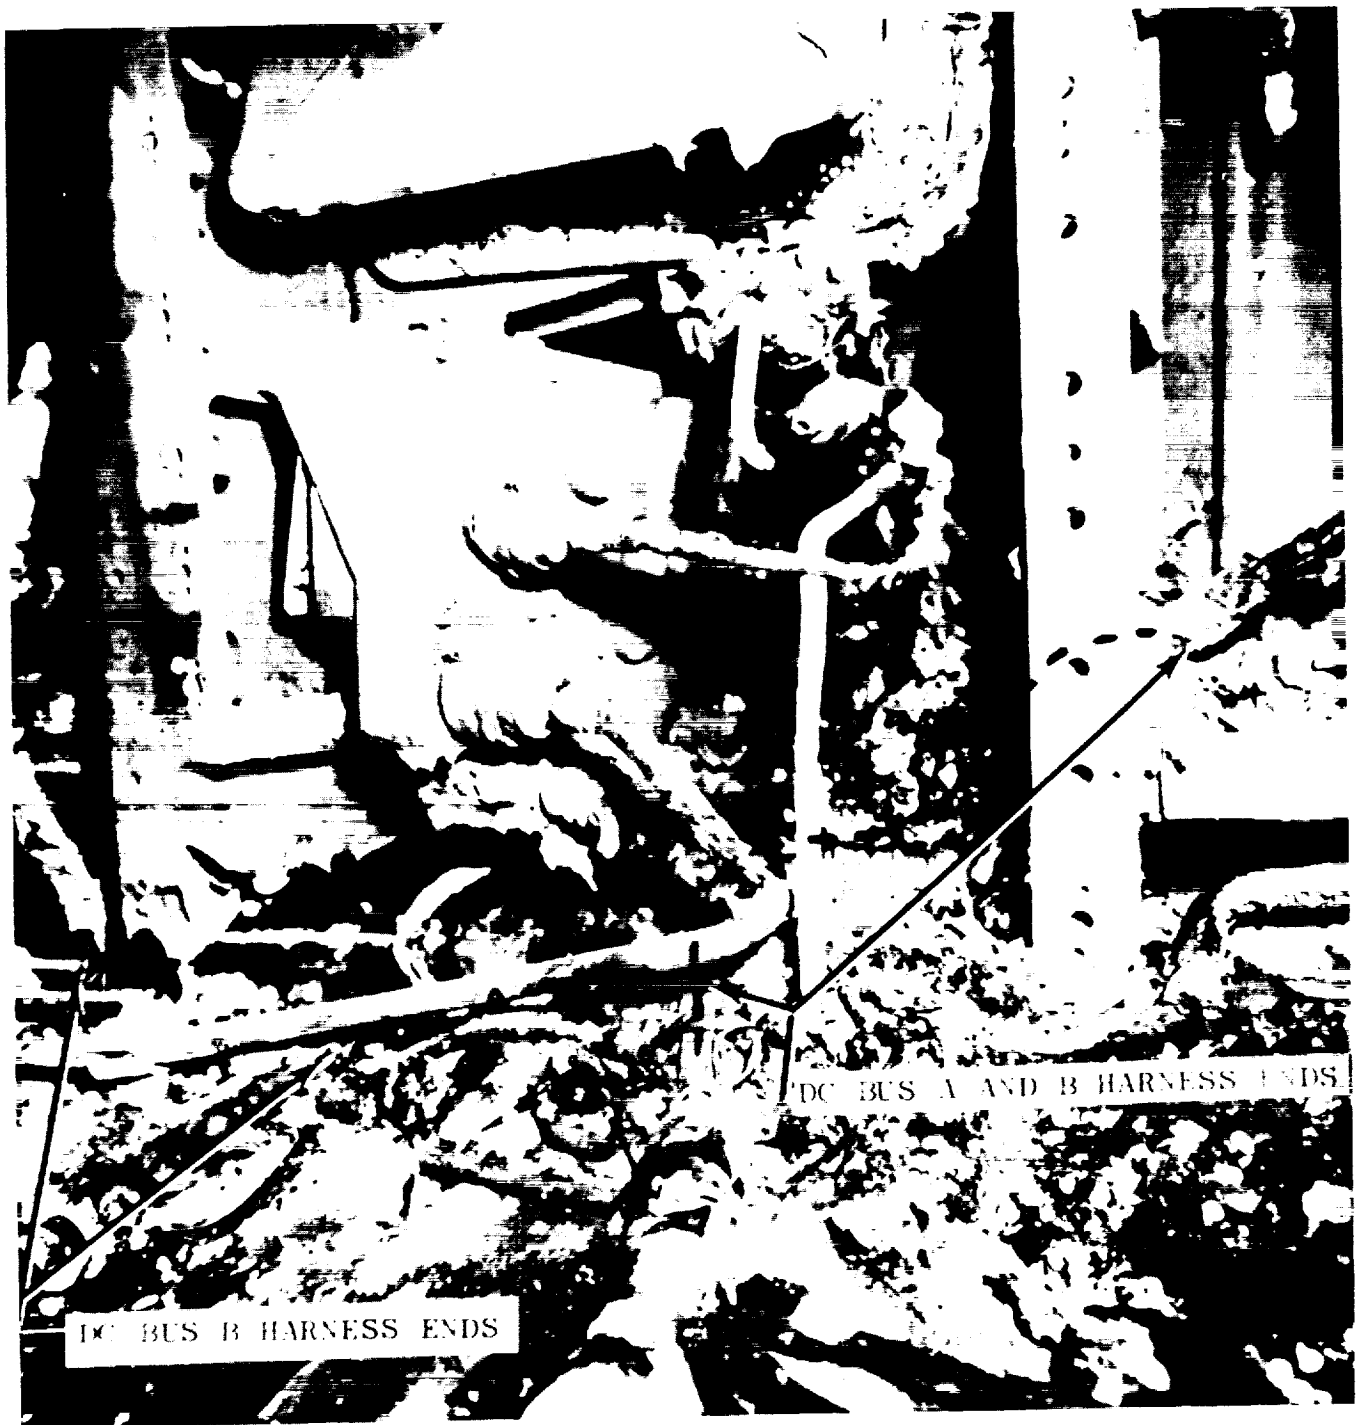
ENCLOSURE V-11

ENVIRONMENTAL CONTROL SYSTEM INSTRUMENTATION HARNESSES  
AFTER ACCIDENT

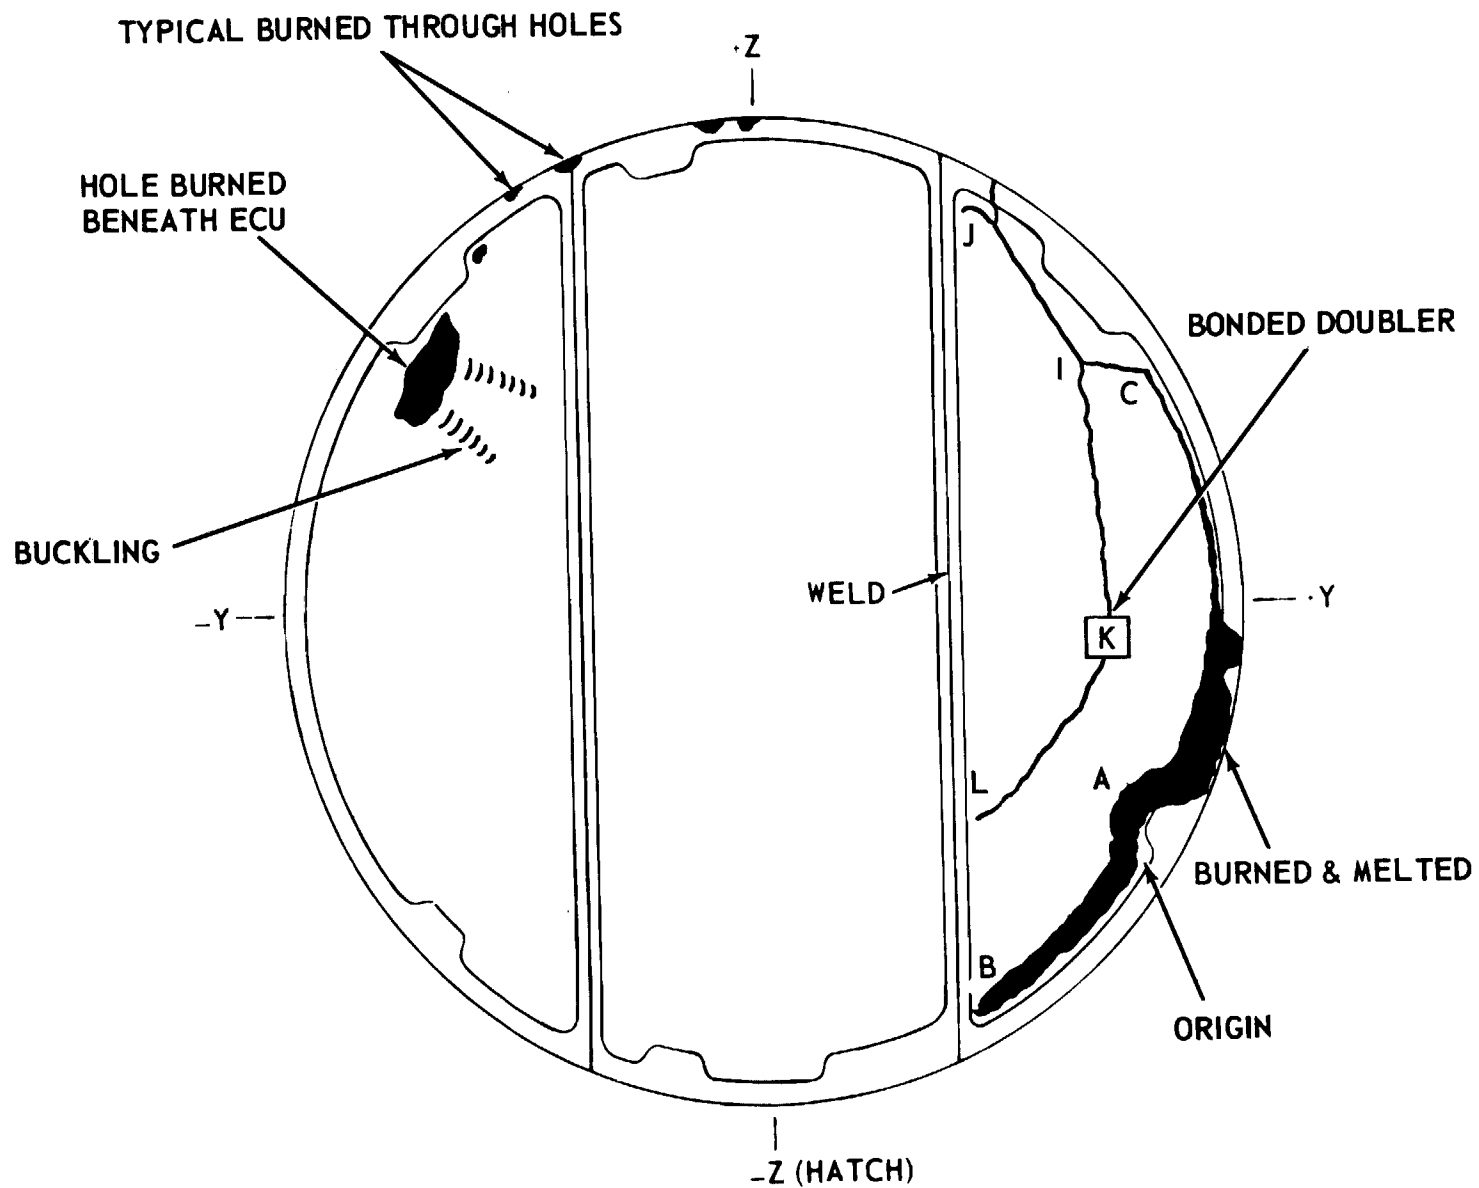
OUTER FACE SHEET OF AFT BULKHEAD

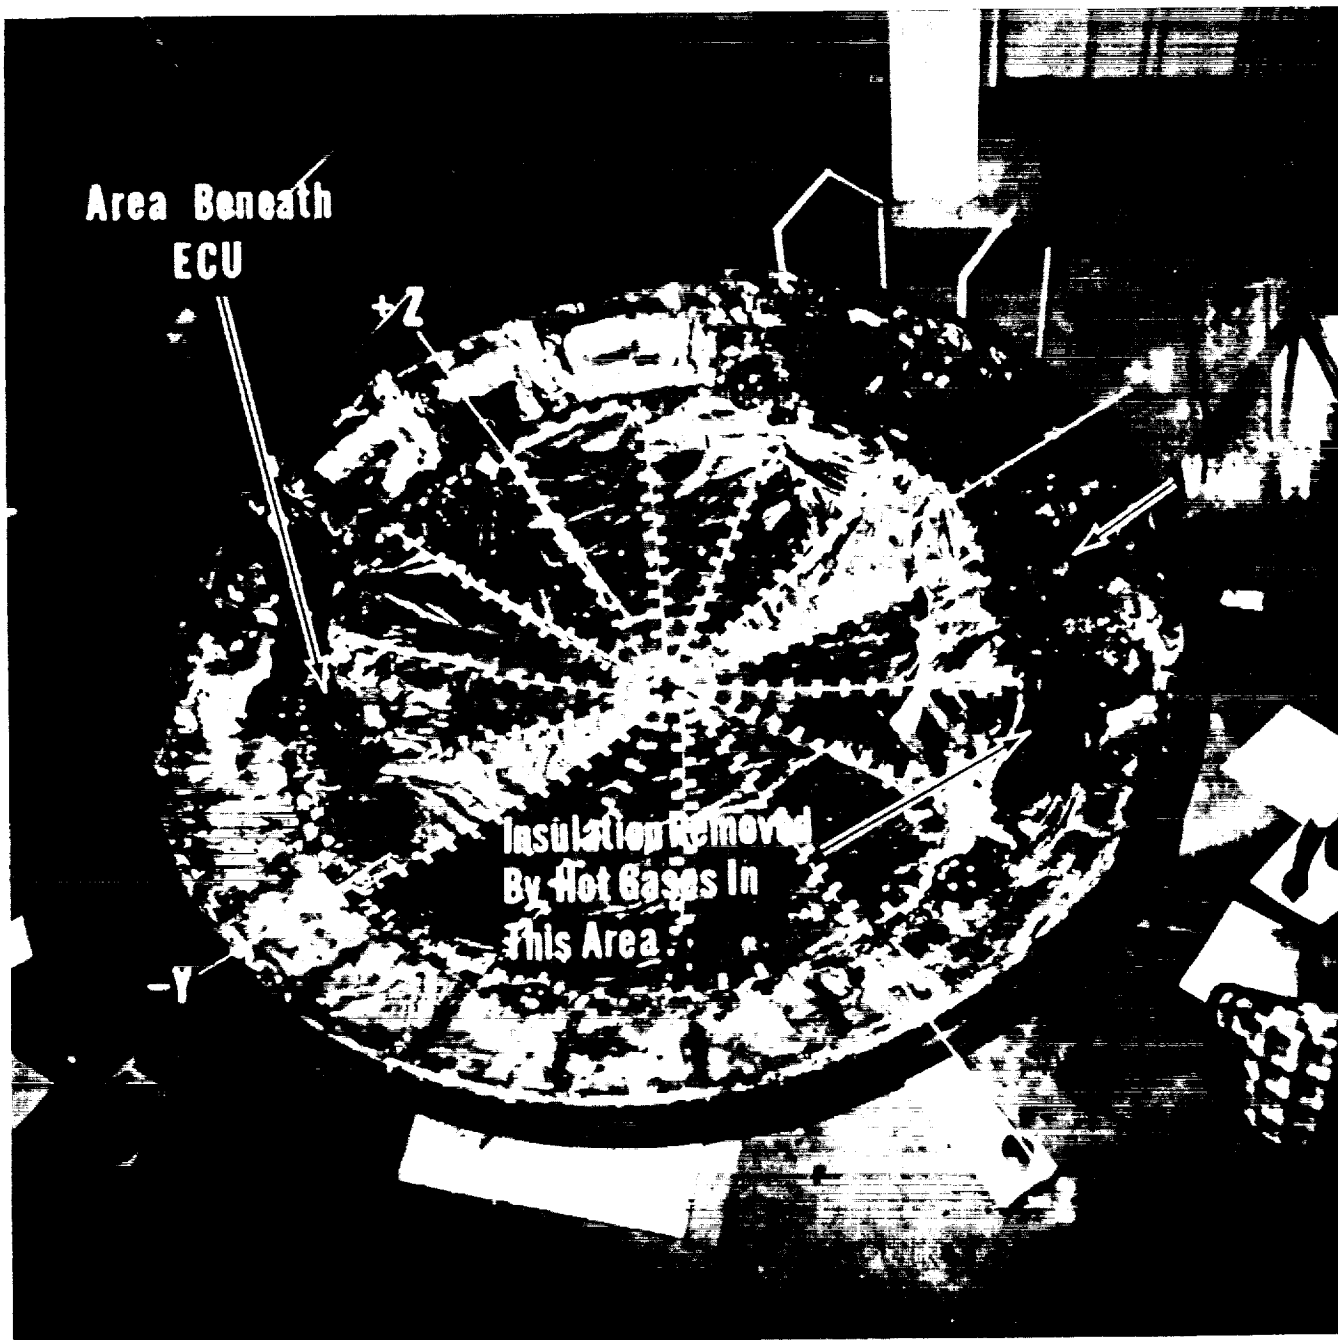
ENCLOSURE V-24

AFT HEATSHIELD DAMAGE

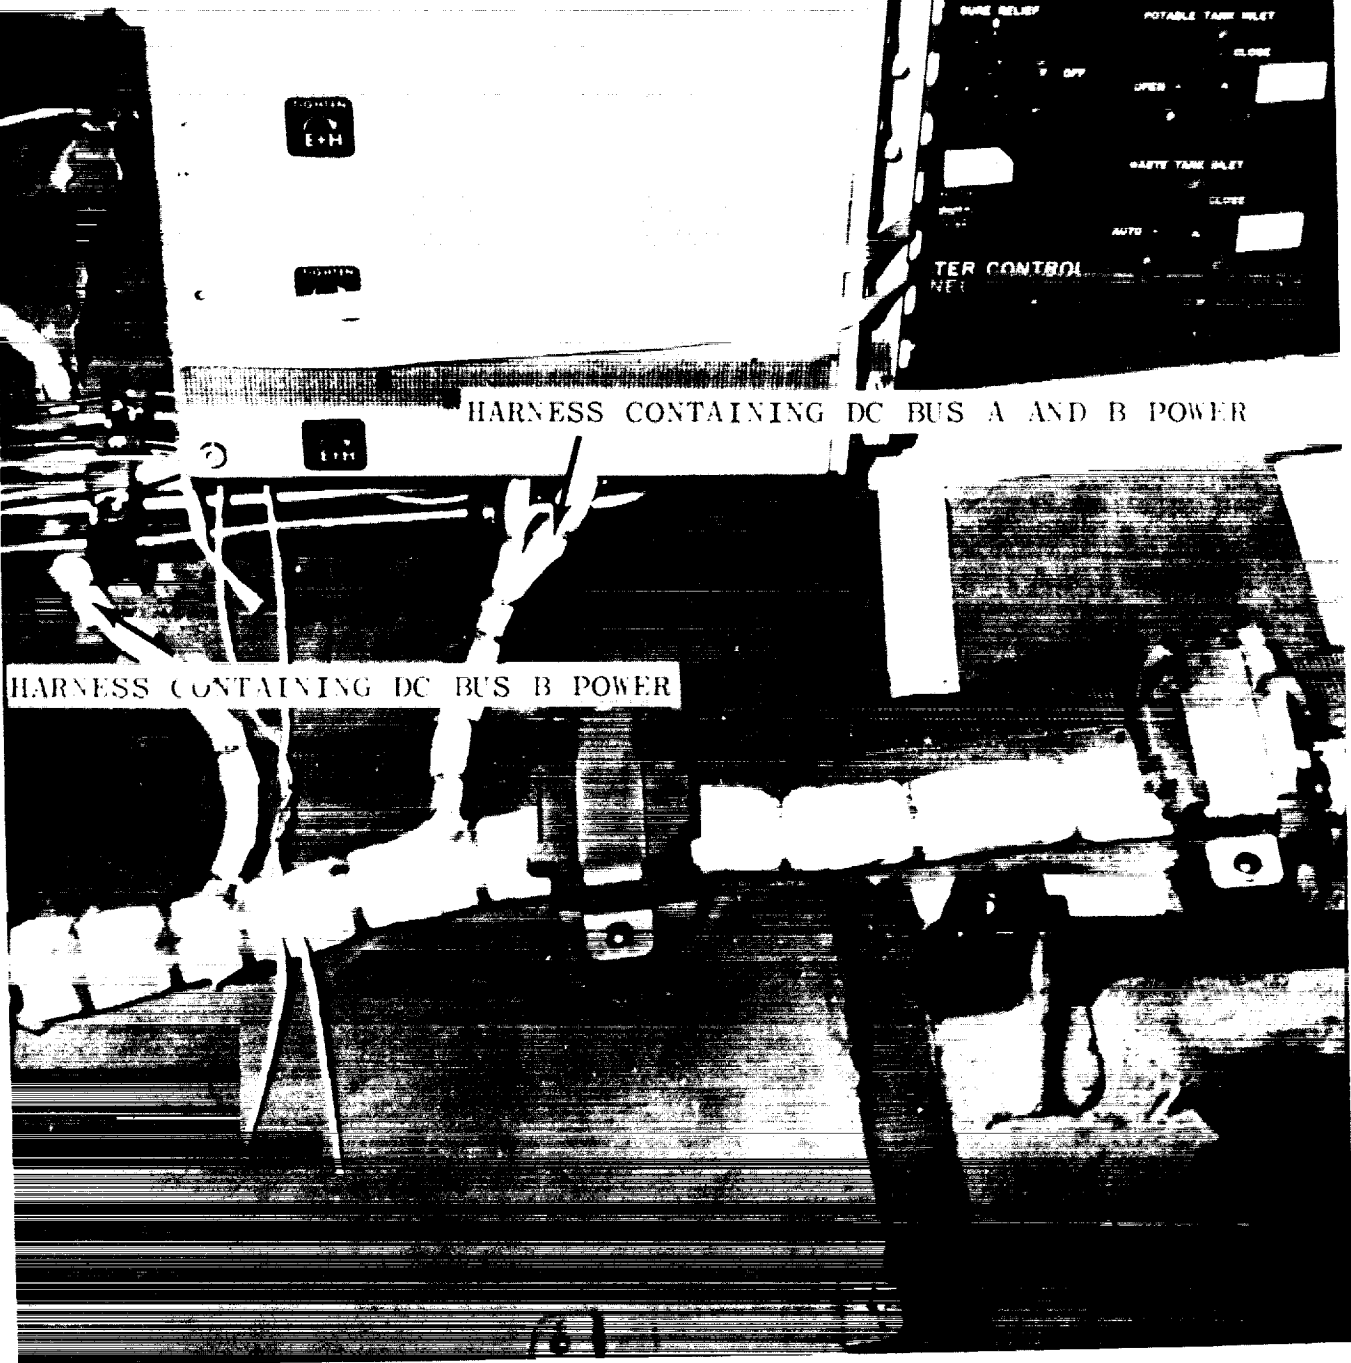
- V - 28      Photograph - View of Wire Bundle in Command Module 014 Containing DC Power Leads Passing Over Tubing and Entering Environmental Control Unit. A Similar Arrangement Existed in Command Module 012.

HARNESS CONTAINING DC BUS A AND B POWER

HARNESS CONTAINING DC BUS B POWER
